QM10512 Mount-QCHF (Quick Change Hopping Foot Adapter)

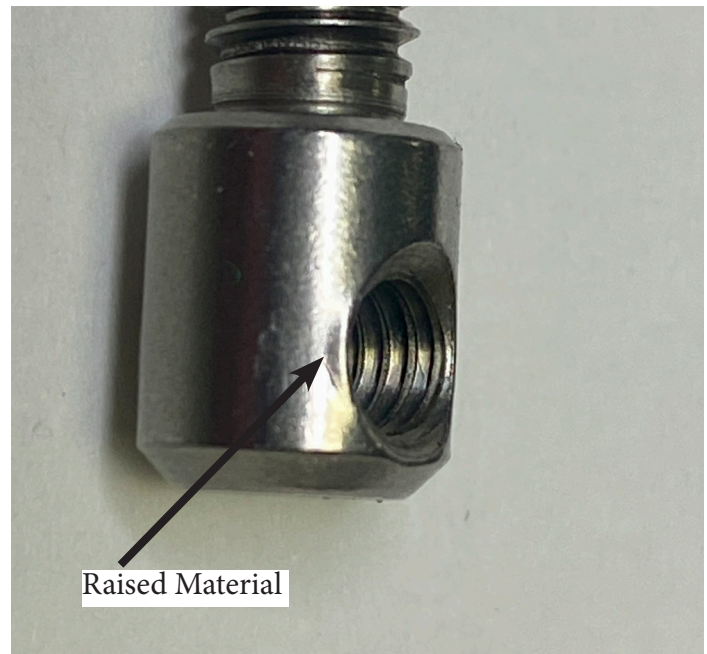
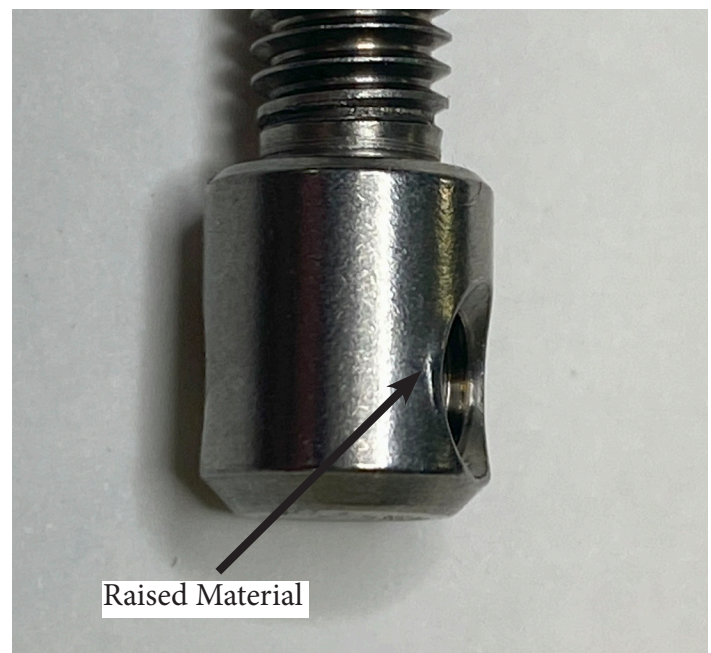
We recently found a batch of Quick Change Hopping Foot mount adapters that have small bulges of raised material near the tapped/threaded hole for the screw that holds the foot on. The raised material at the sides of the hole on both sides appear to be from the countersinking process of the hole. Apparently the last step of polishing these bulges off was missed on this batch. Unfortunately this issue was found after some of these adapters had been used in QM00841 Handi Feet Conversion Kits. At this time we do not believe these foot adapters were used on machines.

The Glide Foot 3 will not go all the way onto the QCHF mount adapter but only to the tapped/threaded hole.

**Note:** Use the Glide Foot 3 as a gauge early and often to know when the raised material has been removed enough for it to fit properly.

- Use a medium (100-160) emery cloth to remove the raised material on each side of the hole and on both sides of the adapter as needed.
- Use a hard Arkansas Stone, to stone off the small ridge of material on each side of the hole and on both sides of the adapter as needed.
- Contact Handi Quilter to have a replacement QM10512 QCHF mount adapter sent out if needed.
